Guidance document GD 07

INSTALLATION AND QUALITY OF WORKMANSHIP

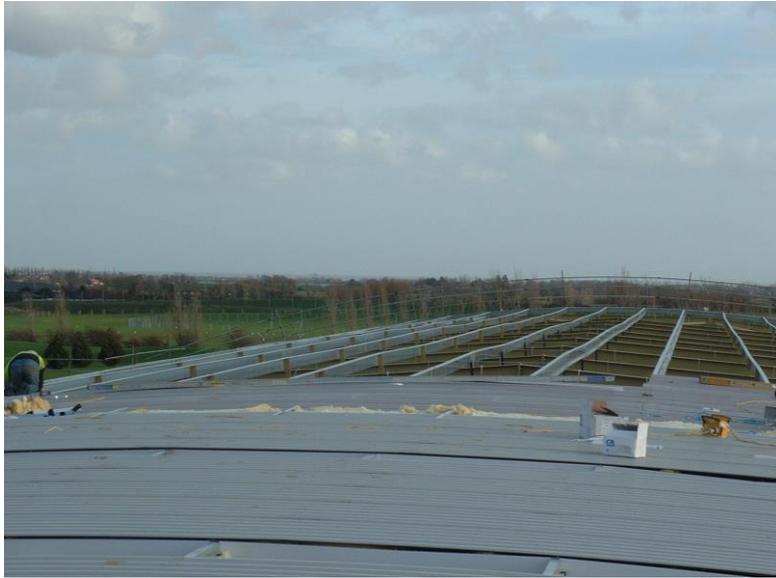
Image 1: Undulating/out of position purlin

Undulating/out of position purlins (image 1) occur when the steel frame is erected at varying heights from rafter to rafter. In this case, rafters are faceted to suit a self-curved twin skin roof cladding system and varying heights of cleats are welded to the faceted rafters to achieve the required curvature. Clearly, a difference in height of the rafters / cleat positions does not achieve the correct purlin lines throughout the roof construction.

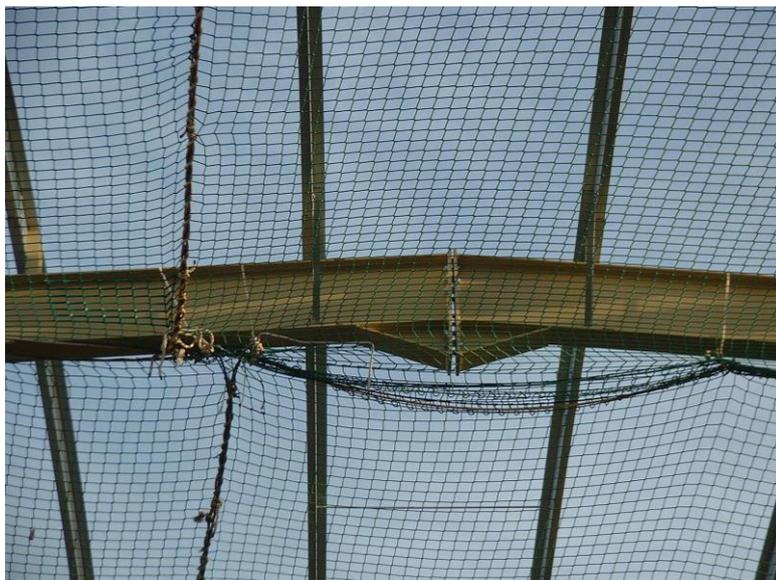
Image 2: Incomplete structural connections

In image 2, the apex connection of the rafters had been left incomplete as above, and then subsequently handed over to the roofing contractor to commence installation of the roof cladding.

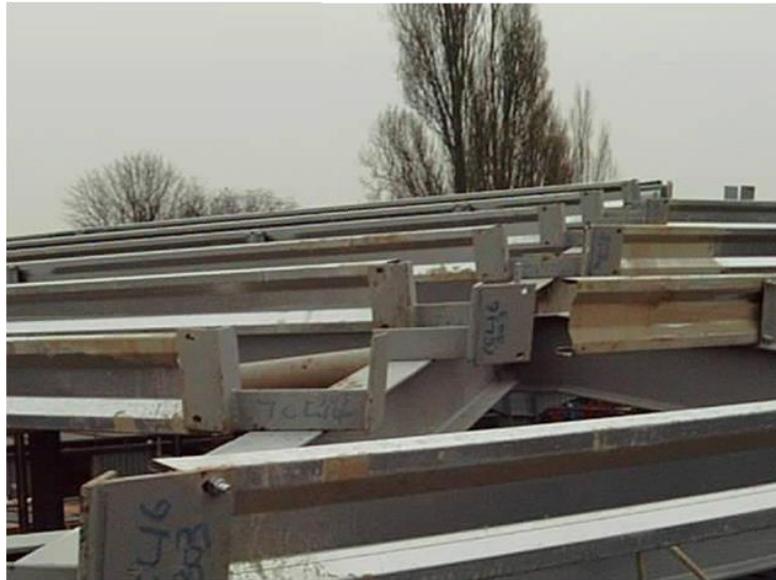
Image 3: Incomplete structural connections

Hip purlins not connected at hip rafter cleats; this not only affects structural capabilities but in addition, there are no structural 'cleaders', which are required to ensure non-fragility of the roofing assembly and an air tight junction being achieved. Purlins locations on hip rafters need consideration as they can clash with the internal gutters as is evident in image 4 below.

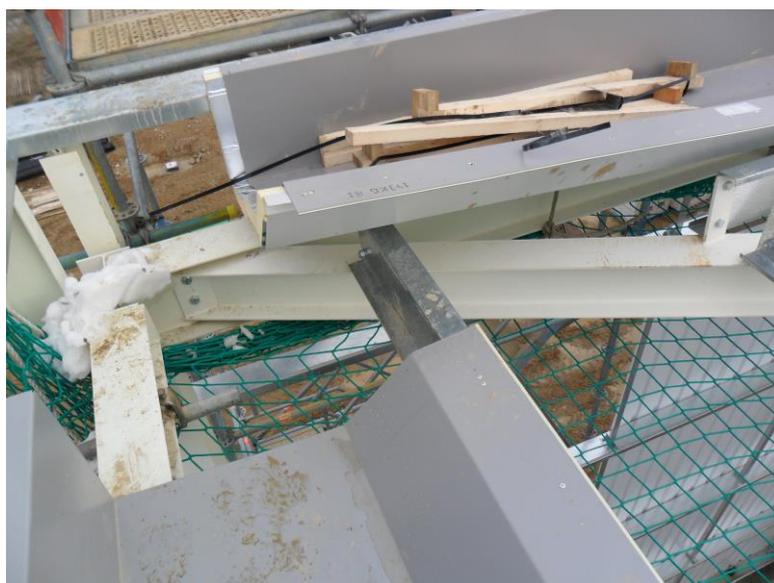
Image 4: Purlin/gutter clash

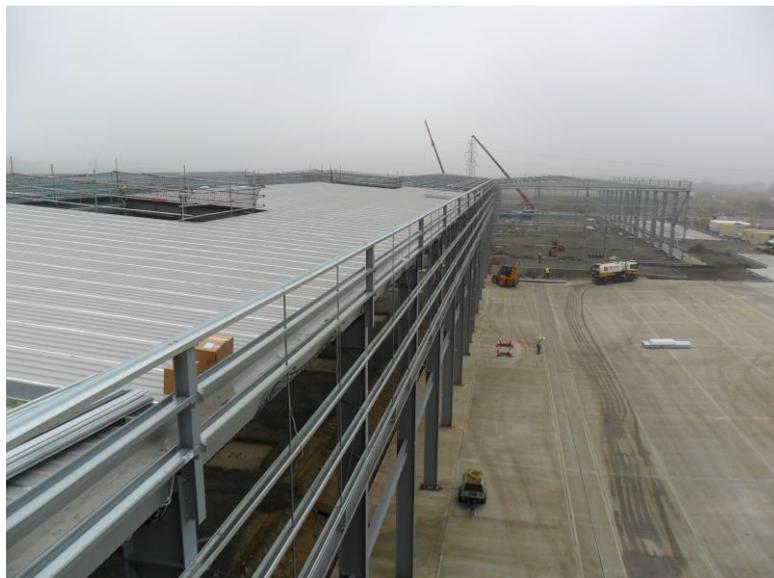
Image 5: Primary and secondary steelwork properly installed

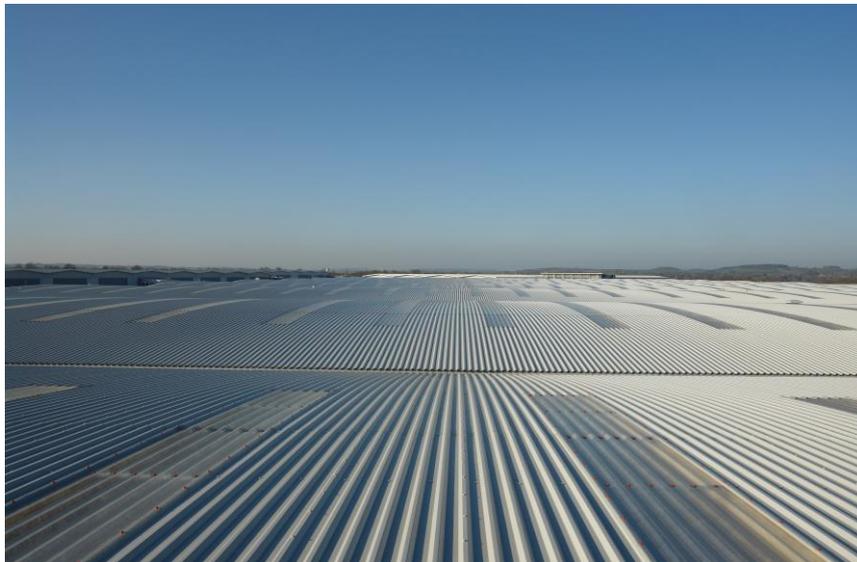
Image 6: Roof cladding

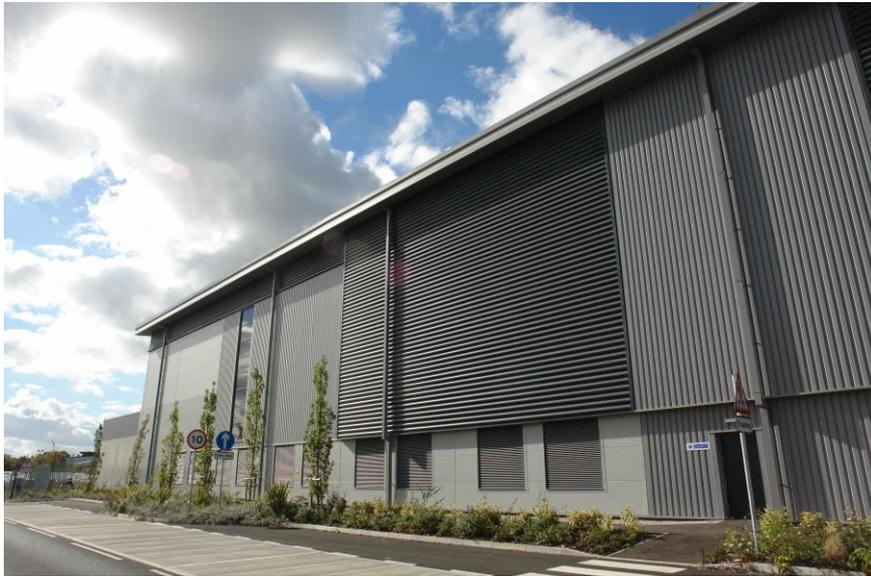
Image 7: Wall cladding
